# Intel Technical Advisory

TA-0921-2

## AXXRSBBU4 Thermistor Mechanical Damage Results in Incorrect Battery Temperature Being Reported.

AXXRSBBU4, MM# 891157

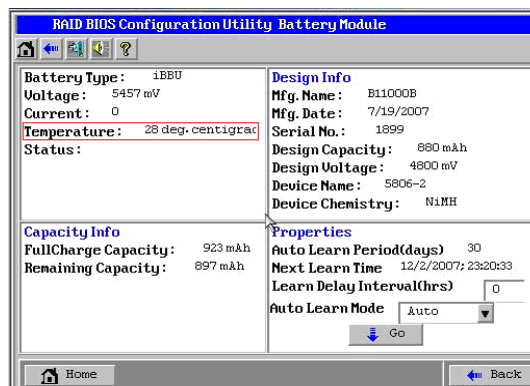
Figure 1

Intel has found that some AXXRSBBU4 may experience an issue with a damaged thermistor. The thermistor damage results in extreme battery temperature values being reported which results in triggering the BBU overheating protection mechanism and prevents the battery from charging. The typical symptom of this issue is a temperature value ~65512 degrees C; however, a value below 16 degrees C can also be reported.

Temperature values reported by the thermistor can be viewed in RAID BIOS Console utility (see Figure 1) or in the RAID Web Console 2 utility (see Figure 2).

Customers may review the AXRSBBU4 temperature values in RAID Bios Console or RAID Web Console 2. Batteries that display an abnormal temperature as described above may be returned for warranty replacement. Battery returns should be managed through the standard product RMA process. Please indicate that you are calling regarding TA# 0921-2, and have the following information when you call; the part number requested, and the serial number(s) for the system(s) or board(s) needing the replacement part.

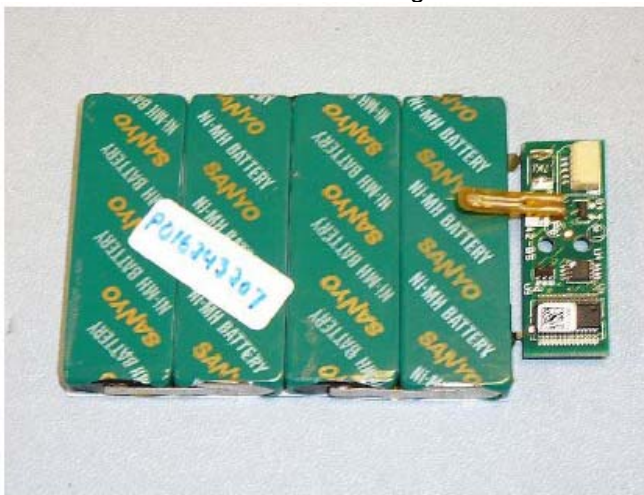
Cause of the thermistor damage has been determined to result from improper handling at the last stage of the test process. Pictures below show the disassembled thermistor and battery cell pack in figure 3, and the gas gauge circuit board with thermistor attached in Figure 4.

**Figure 3 : Gas Gauge and Battery assembly**

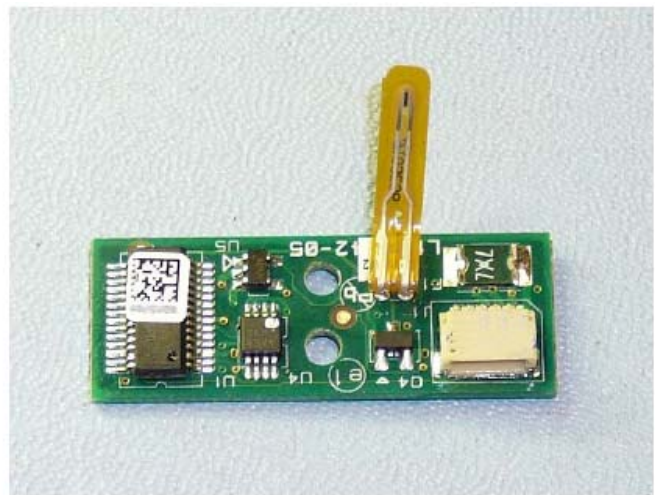
**Figure 4 : Gas Gauge board**

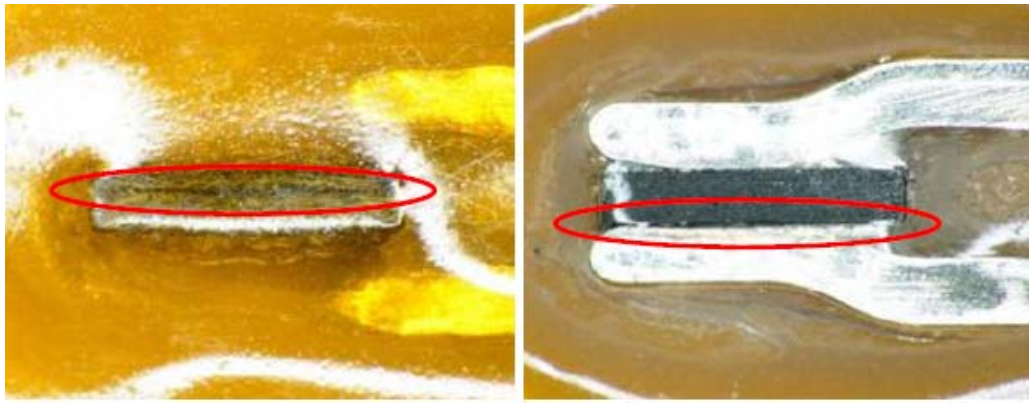
Figure 5 shows damaged detected in the thermistor elements.

**Figure 5: Damaged Thermistor Elements**

Additional analysis of these fractures proved that separation of the element along the fracture line results in incorrect values being reported to the gas gauge circuitry.

Product with MM#891157 is no longer in production and has been replaced by product with MM#899346 which is based on LiON battery technology. An additional functional test has been implemented for this updated product that includes a test designed to catch damage to the thermistor, and a plastic shroud has been added to provide additional protection to the thermistor and battery cell pack.
