TA-1167-02

Intel Technical Advisory

December 06, 2021

Intel[®] Server M50CYP Family have a hardware setting that prevents functionality of Intel[®] Trusted Execution Technology (Intel[®] TXT)

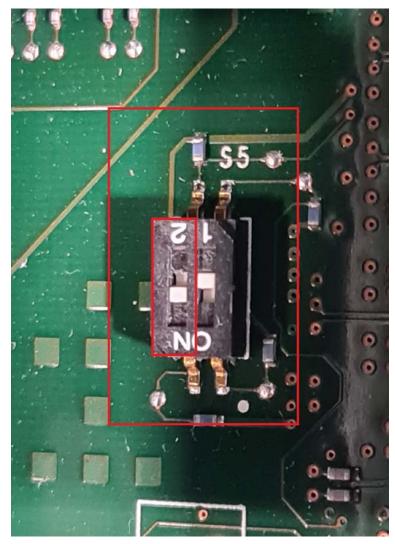
DIP Switch S5_2 switch position on the Intel[®] Server M50CYP family board is incorrectly set to "ON", which prevents the system from enabling Intel[®] Trusted Execution Technology; the S5_2 incorrect switch pin setting can be observed in the following picture.

To restore the ability to enable Intel[®] TXT, the Intel[®] M50CYP motherboard S5_2 switch pin must be manually moved from "ON" to "OFF" position, as shown in the pictures below. Unplug AC cord from server system before moving the pin number 2 on the S5 switch.

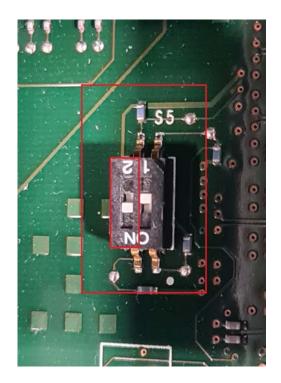
The DIP Switch S5_2, which controls whether Intel® Trusted Execution Technology (Intel® TXT) may be enabled or not, is set incorrectly as shipped on the affected products. This switch is set to "ON" (which disables Intel® TXT) instead of "OFF" (which allows Intel® TXT to be enabled if the user desires). As a result, technologies, which depend upon Intel® TXT, such as the Microsoft Windows* Server 2022 and Azure* Stack HCI OSes Secured-Core capabilities, cannot be completely enabled prior to applying the below-documented resolution on the affected products.

"Incorrect S5_2 "ON" position"

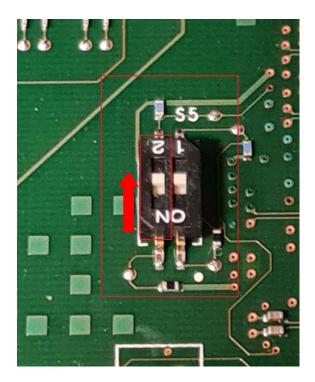
"Correct S5_2 "OFF" position"

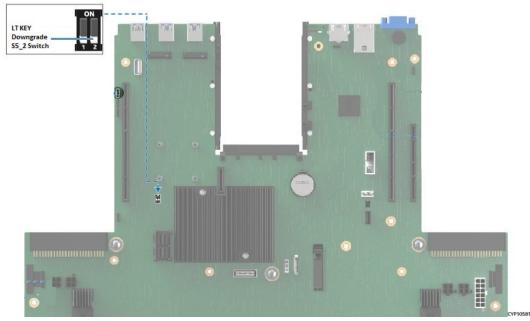
The location of S5 switch can be observed in the picture below:
