Intel[®] 82576EB Gigabit Ethernet Controller Specification Update

LAN Access Division (LAD)

**Revision 2.9
June 2014**

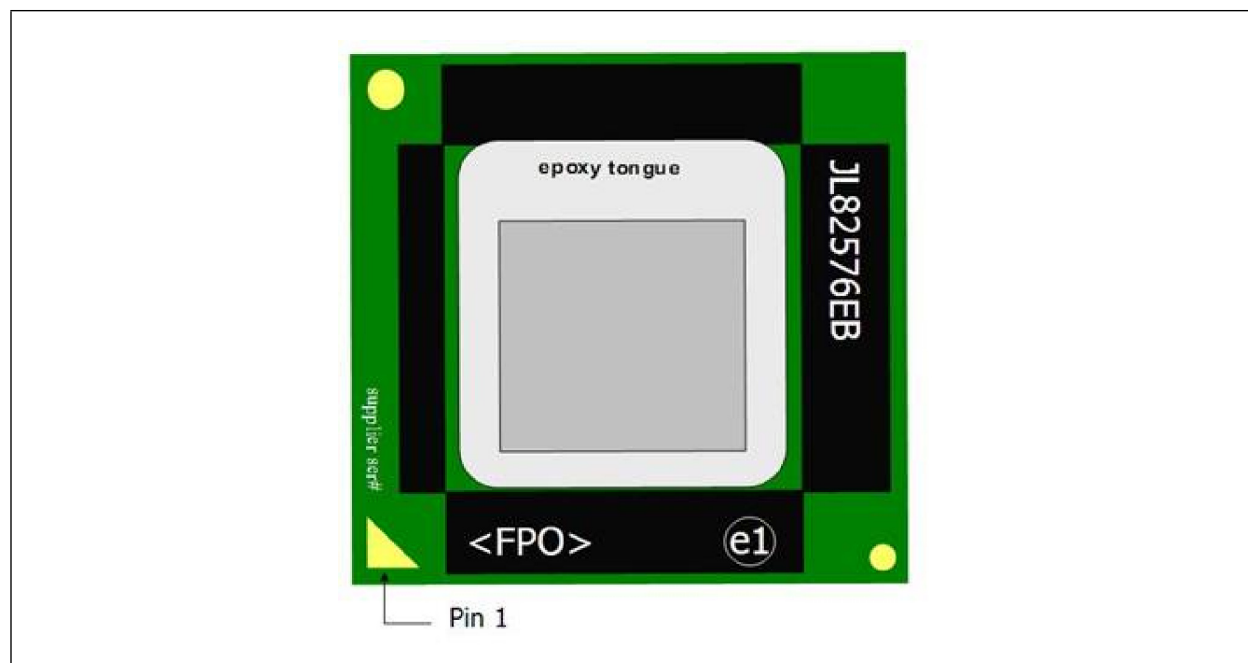
Figure 1. Example With Identifying Marks

Lead-free parts will have “JL” as the prefix for the product code (vs. “HL”).

The devices can also have a “GB” marking, instead of “EB”. These are functionally equivalent and only used on Intel network interface adapters.

There is an internal designator visible as a dash on the die side of some packages. It’s location may differ. The mark (looks like a dash, approximately 300X1000 µm in size) does not impact function.
