Intel® Celeron® M Processor

Specification Update

July 2008

Revision 040

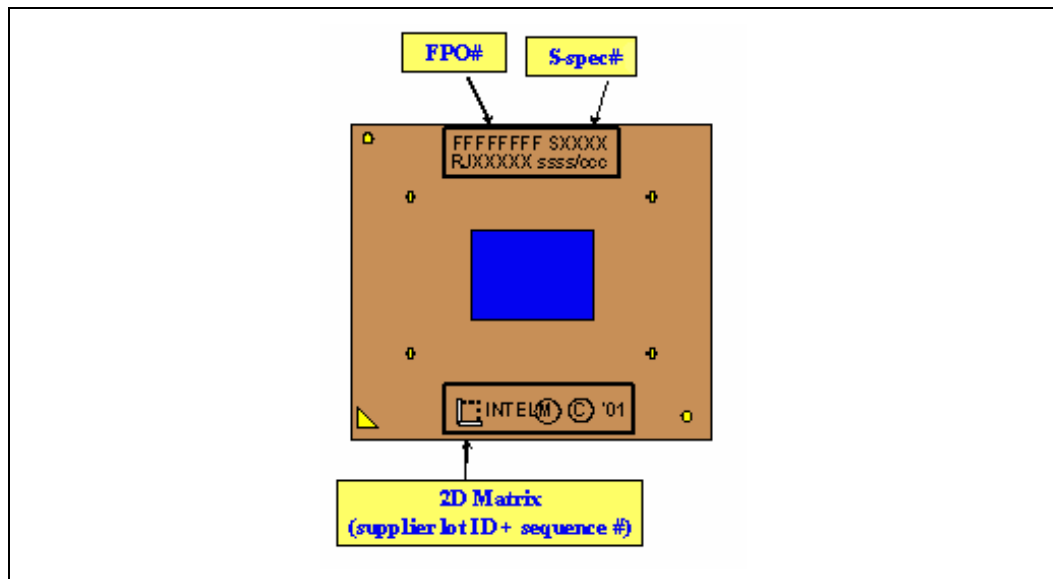
Figure 1. Intel Celeron M Processor (Micro-FCPGA/FCBGA) S-Spec Markings
