# Intel<sup>®</sup> Quark<sup>™</sup> SoC X1000

Specification Update

*August 2014*

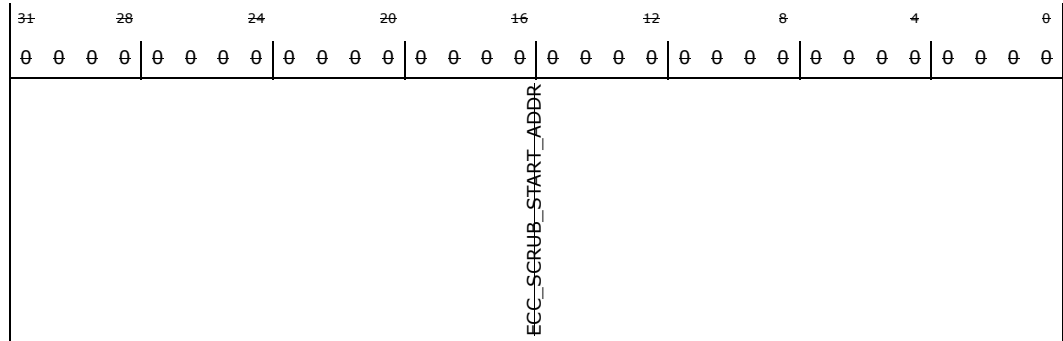
Bit-Range	Default & Access	Field-Name (ID): Description
31:0	0b RW	<b>Start Address (ECC_SCRUB_START_ADDR):</b> Start of memory address.

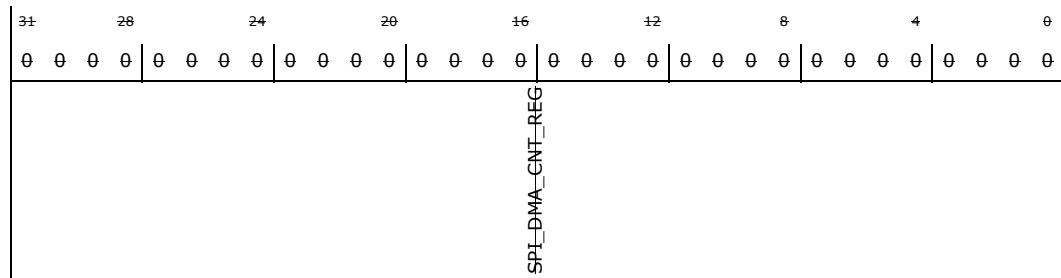
Bit-Range	Default & Access	Field Name (ID): Description
31:0	0b RW	<b>SPI DMA Count (SPI_DMA_CNT_REG):</b> Count of 512-byte block transfers. Writing this register triggers the start of the transfer of the indicated number of blocks. Reading this register returns the number of blocks that are remaining to be transferred. A value of 0 indicates the transfer is complete.

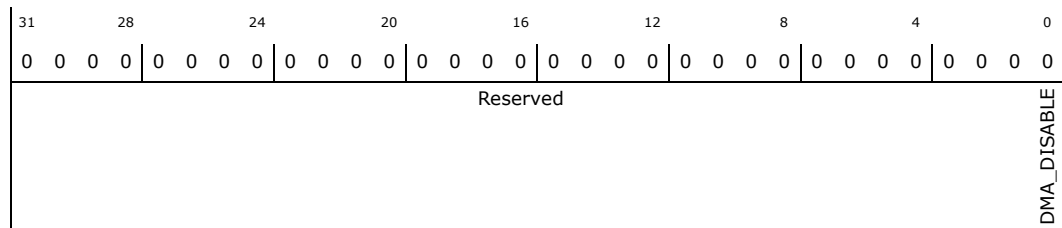
Bit Range	Default & Access	Field Name (ID): Description
31:1	0 RO	<b>Reserved (RSVD):</b> Reserved.
0	0 RW	<b>DMA_DISABLE:</b> Remote Management Unit DMA disable. Once set RMU DMA functionality is disabled until system reset

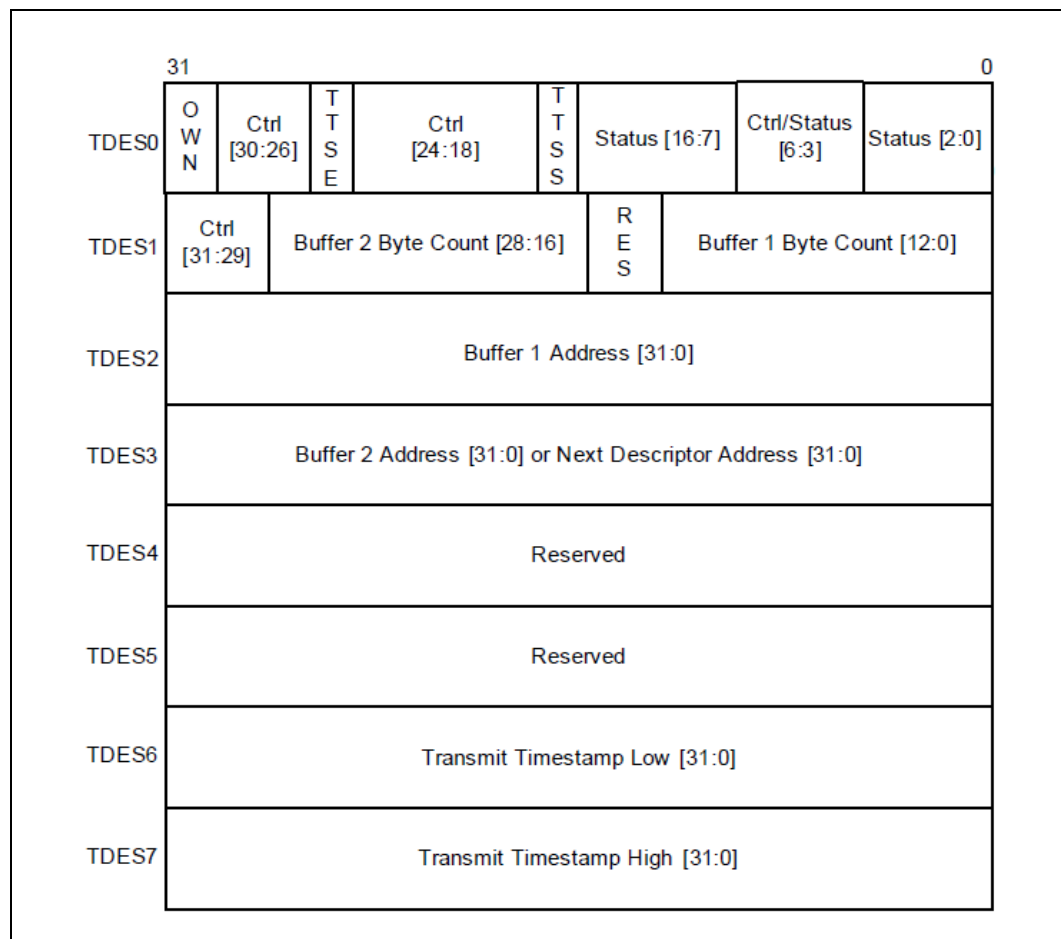
Figure 1. Transmit Descriptor Fields

The transmit descriptor structure is shown in Figure 1. The application software must program the control bits TDES0[31:18] during descriptor initialization. When the DMA updates the descriptor, it writes back all the control bits except the OWN bit (which it clears) and updates the status bits[7:0]. The contents of the transmitter descriptor word 0 (TDES0) through word 3 (TDES3) are given in Table 1 through Table 3, respectively.

The snapshot of the timestamp to be taken can be enabled for a given frame by setting Bit 25 (TTSE) of TDES0. When the descriptor is closed (that is, when the OWN bit is cleared), the timestamp is written into TDES6 and TDES7. This is indicated by the status Bit 17 (TTSS) of TDES0 shown in Figure 1. The contents of TDES6 and TDES7 are mentioned in Table 5 and Table 6.
