Intel[®] Quark[™] SoC X1000

Specification Update

June 2014

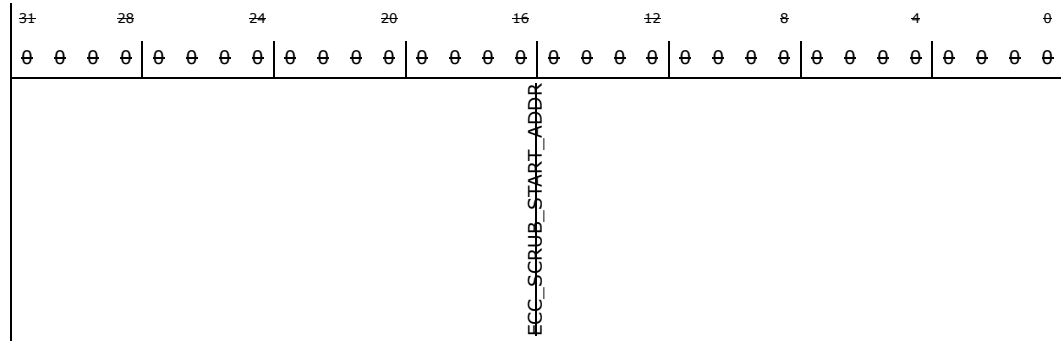
Bit-Range	Default & Access	Field-Name (ID): Description
31:0	0b RW	Start Address (ECC_SCRUB_START_ADDR): Start of memory address.

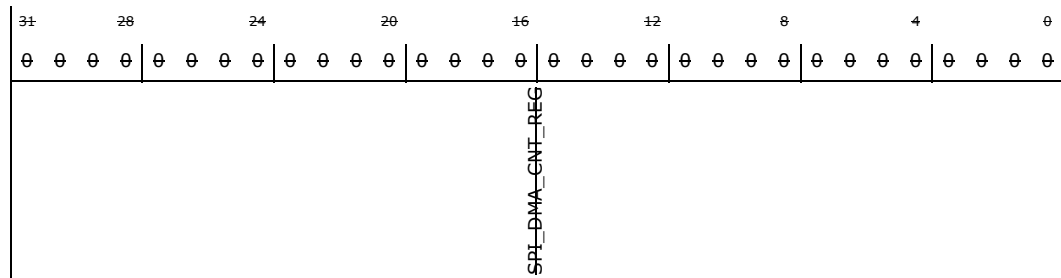
Bit-Range	Default & Access	Field Name (ID): Description
31:0	0b RW	SPI DMA Count (SPI_DMA_CNT_REG): Count of 512 byte block transfers. Writing this register triggers the start of the transfer of the indicated number of blocks. Reading this register returns the number of blocks that are remaining to be transferred. A value of 0 indicates the transfer is complete.

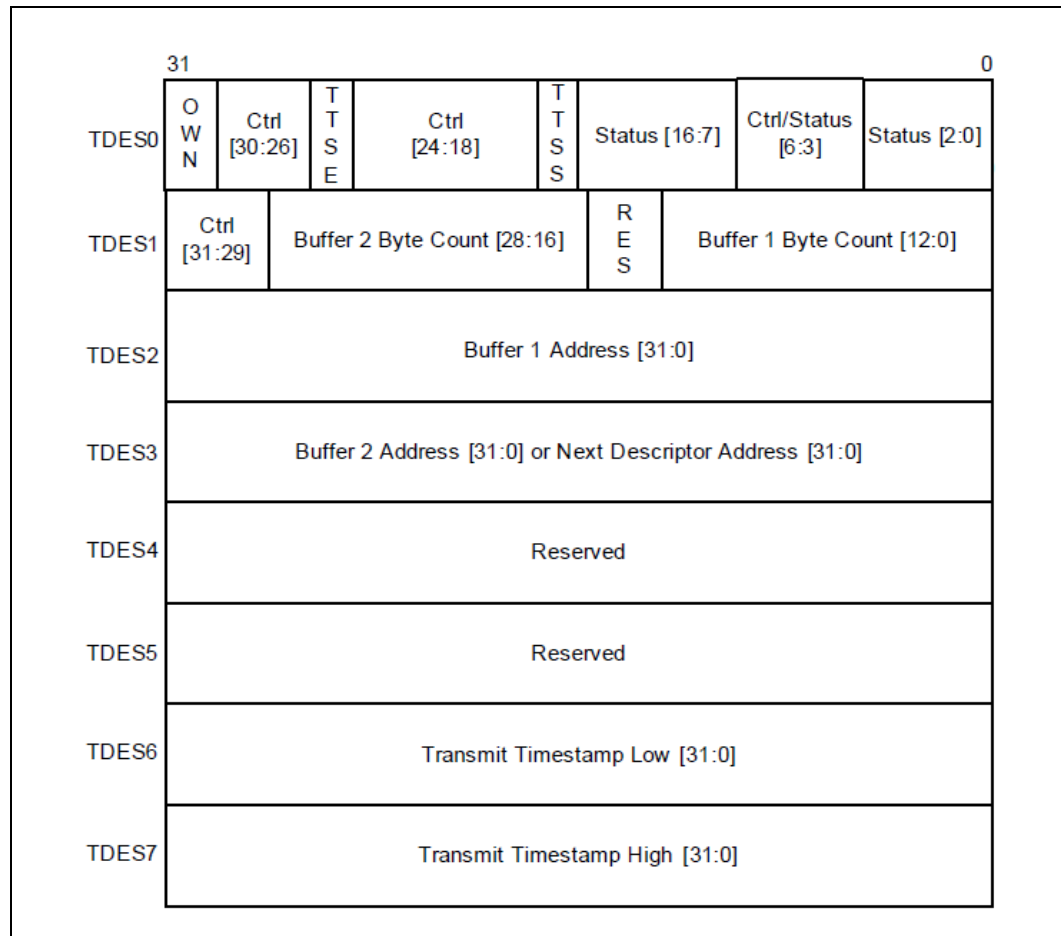
Figure 1. Transmit Descriptor Fields

The transmit descriptor structure is shown in Figure 1. The application software must program the control bits TDES0[31:18] during descriptor initialization. When the DMA updates the descriptor, it writes back all the control bits except the OWN bit (which it clears) and updates the status bits[7:0]. The contents of the transmitter descriptor word 0 (TDES0) through word 3 (TDES3) are given in Table 1 through Table 3, respectively.

The snapshot of the timestamp to be taken can be enabled for a given frame by setting Bit 25 (TTSE) of TDES0. When the descriptor is closed (that is, when the OWN bit is cleared), the timestamp is written into TDES6 and TDES7. This is indicated by the status Bit 17 (TTSS) of TDES0 shown in Figure 1. The contents of TDES6 and TDES7 are mentioned in Table 5 and Table 6.

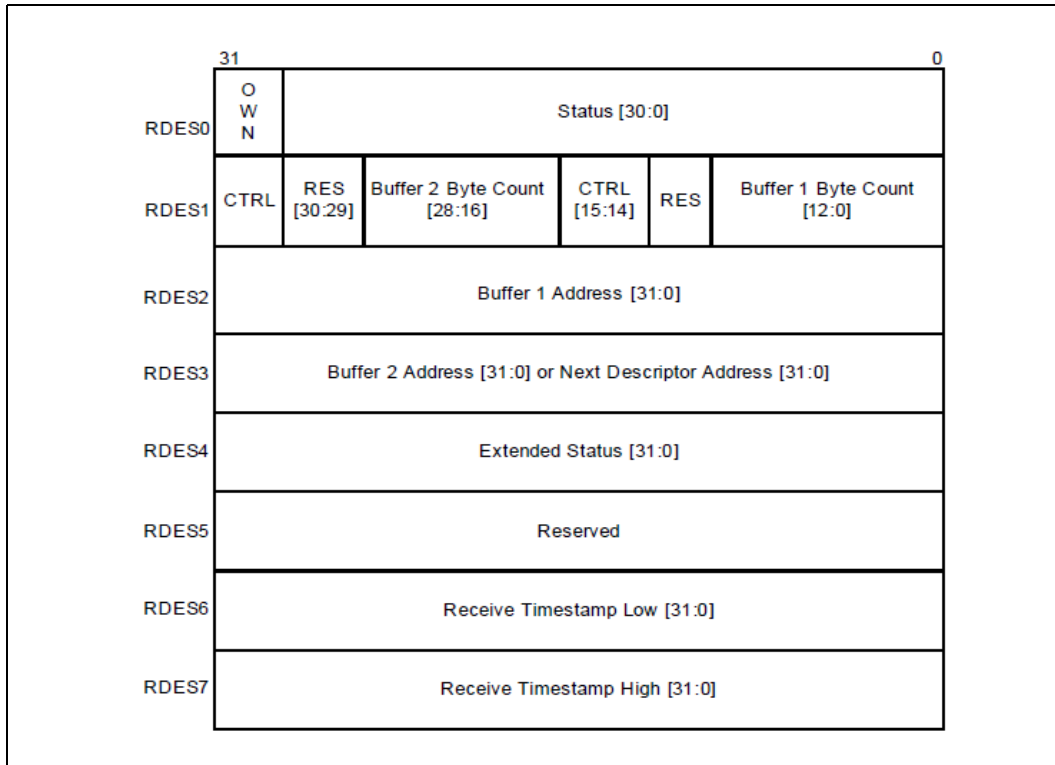
Figure 3. Receive Descriptor Fields

The structure of the received descriptor is shown in [Figure 3](#). It has 32 bytes of descriptor data (8 DWORDs).

The contents of RDES0 are identified in [Table 7](#). The contents of RDES1 through RDES3 are identified in [Table 8](#) through [Table 10](#), respectively.
